BUREAU OF SHIPS GROUP TECHNICAL INSPECTION REPORT

OPERATION CROSSROADS. U.S.S. INDEPENDENCE (CVL22)

TEST ABLE

VOLUME 1 OF 4 [U].

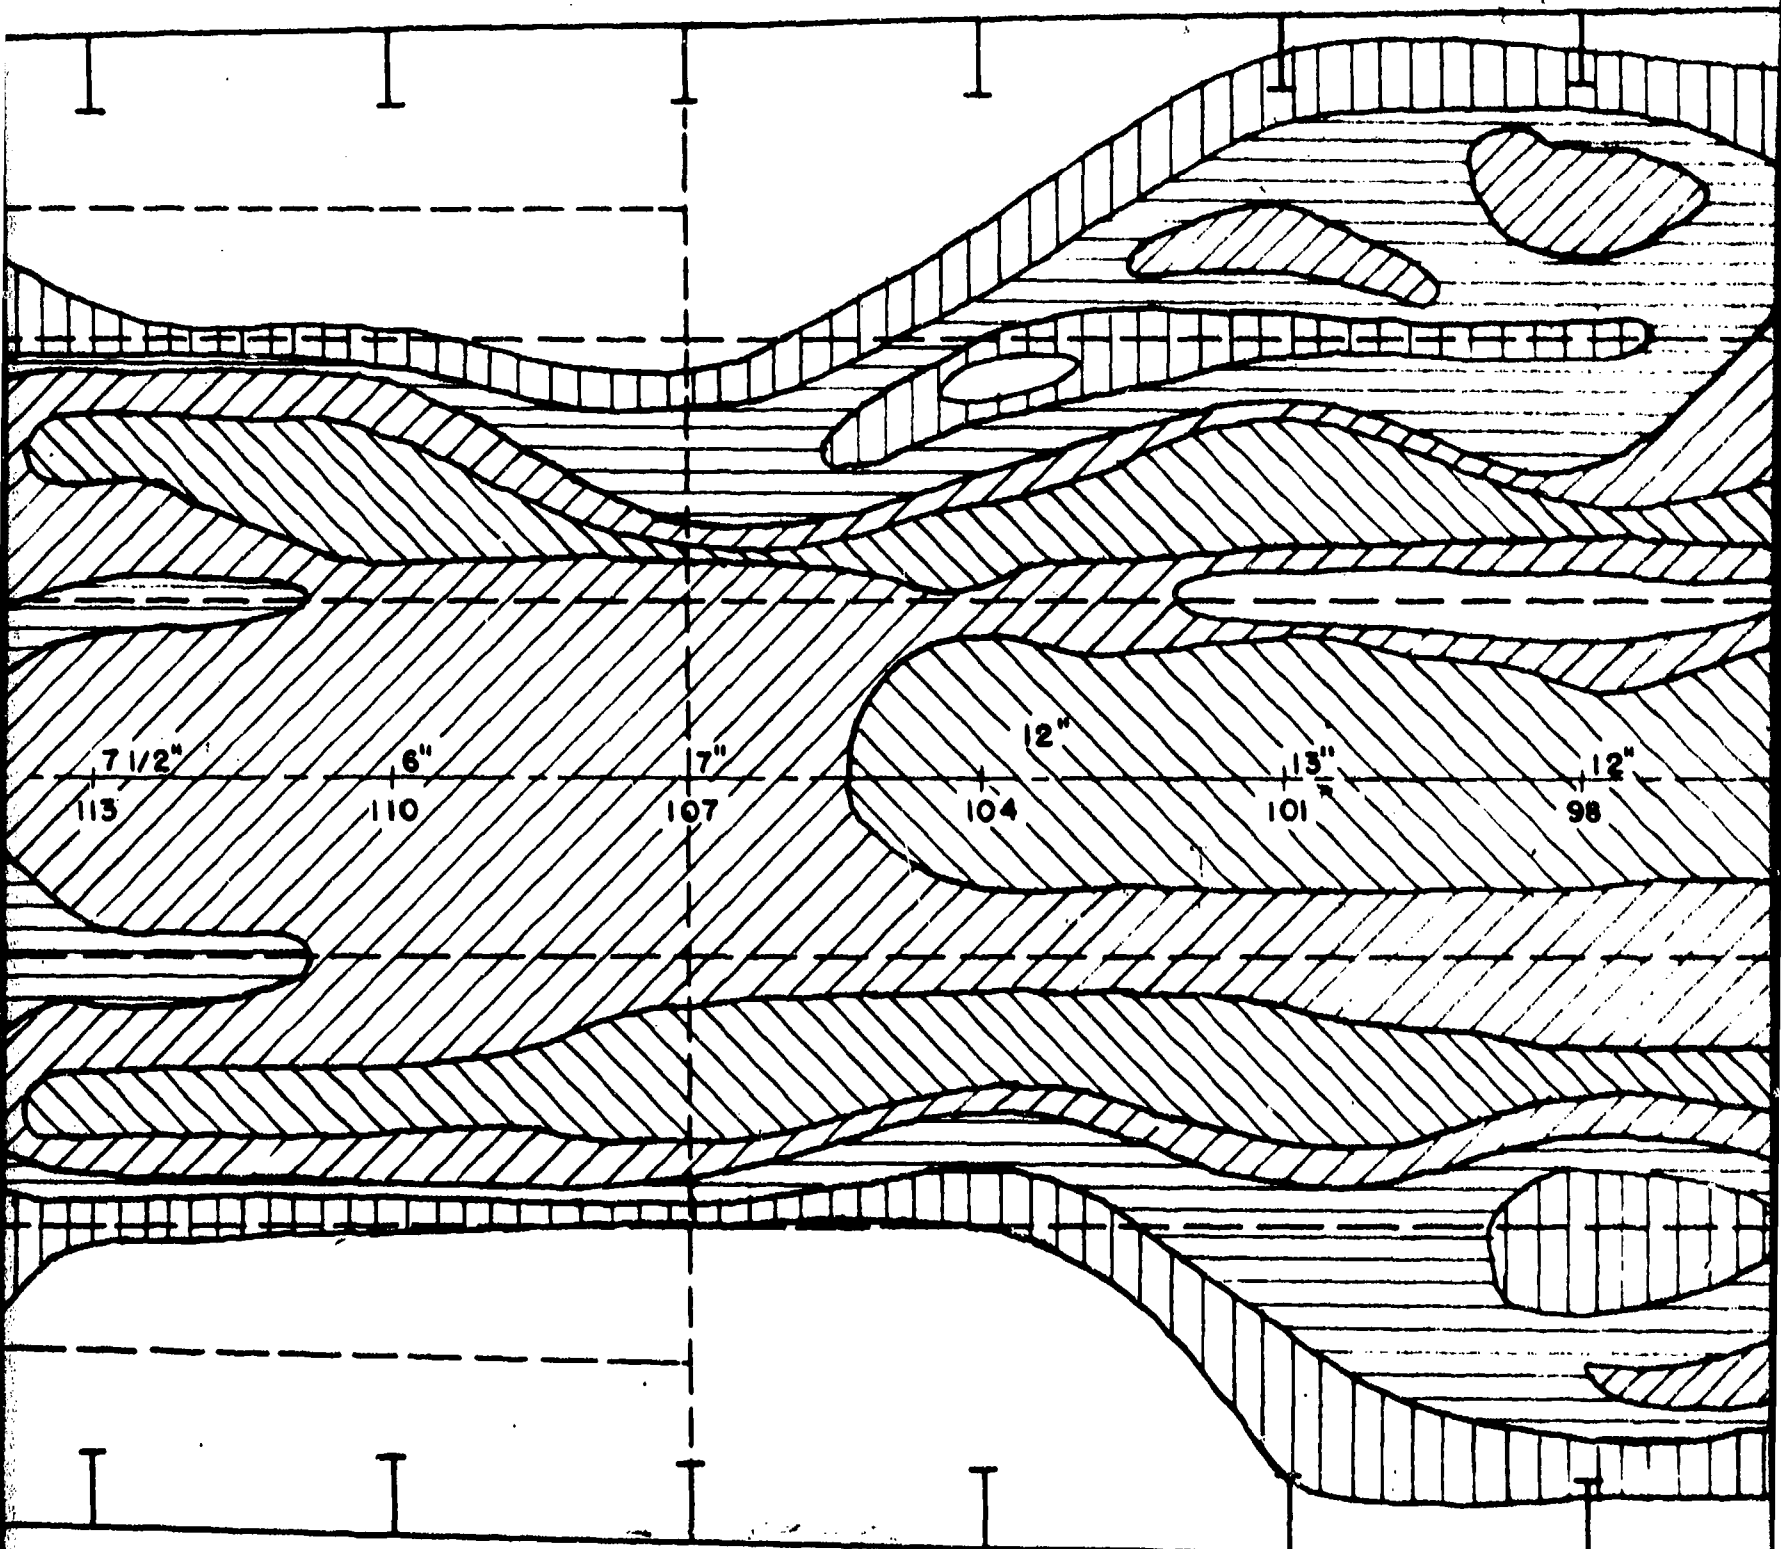
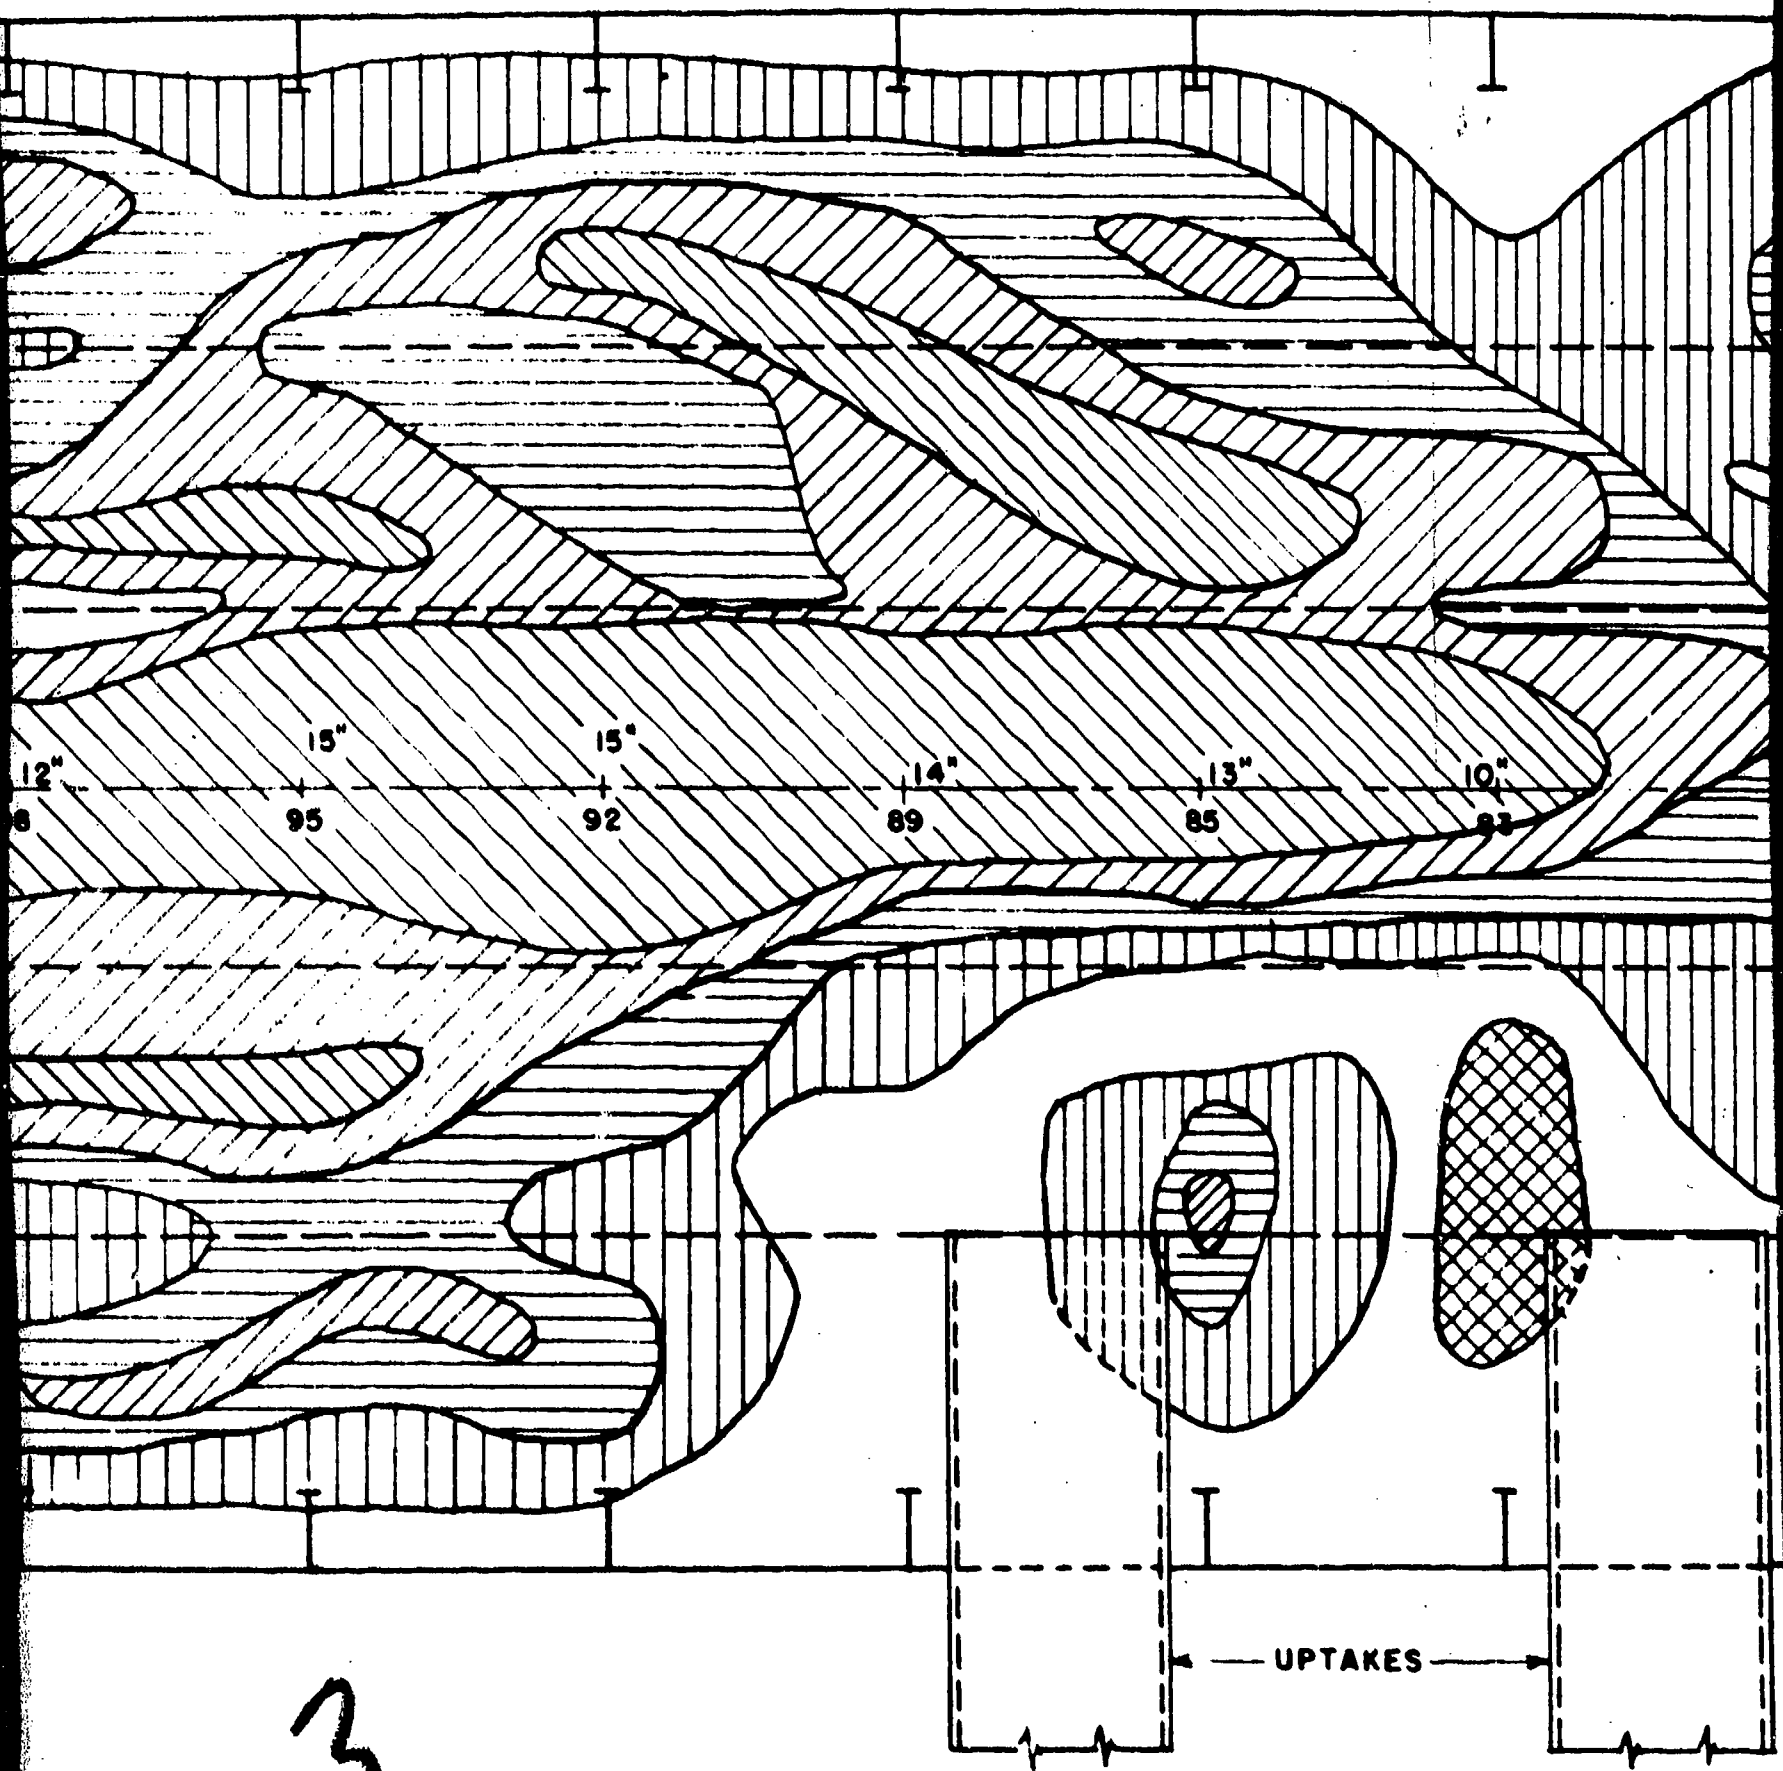
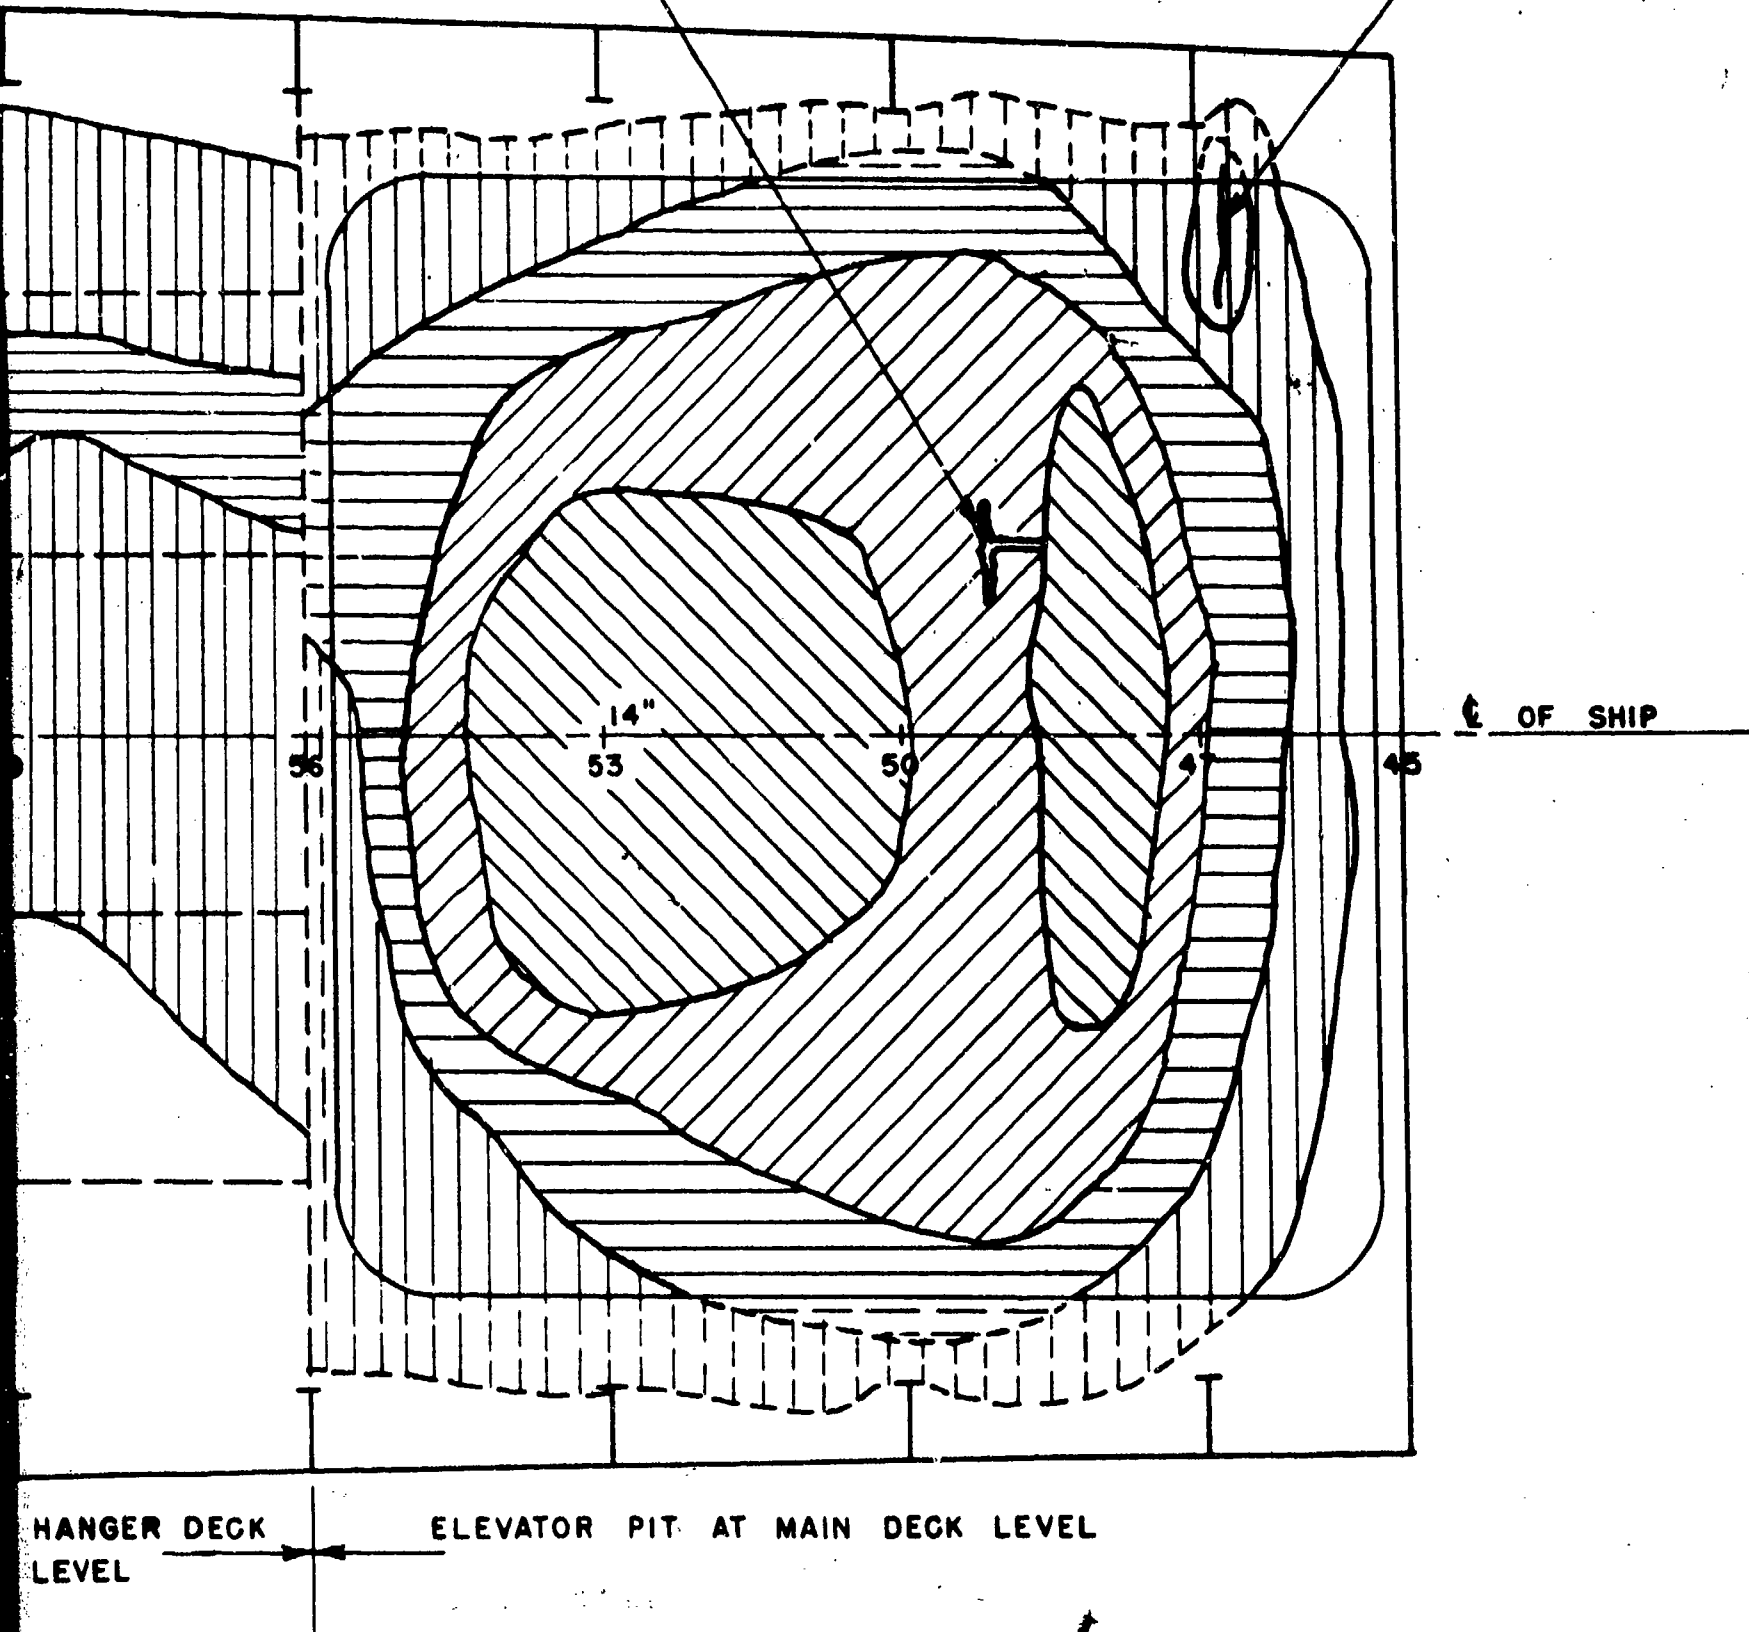
PLATE NO. 4 A

The hangar deck, which extends from frame 57 to frame 115, is generally and severely depressed. This deck is four feet above the main deck and is supported by a series of longitudinal and transverse plat floors. The longitudinal floors are located approximately 7 and 17 feet from the centerline, port and starboard, with flat bar stiffeners located 12 feet each side of the centerline at every frame. There is no longitudinal on the centerline. The omission of a longitudinal here results in a 14 foot span and accounts for the severe depression the full length of the deck. The deck survey figures on plates 41 and 42 which apply to the hangar deck have been gathered into an approximate contour map of this deck in plate 4A and show that the maximum pressure effect within the hangar occurred between frames 89 and 98 on the centerline of the ship where the depression is 15 inches. The area most affected is between frames 83 and 104 over the entire width of the deck. Although there is dishing between the transverse floors, the most noticeable pattern is created by the longitudinals and is shown on pages 279, 280, 282, 285, 286, 287, and 289; see also plate 4A.

FAILED BELOW
122 .

IN WAY OF RIVETED CONNECTION
SIDE OF MAIN DK. OVER BHD. 49.

FAILURE IN WELDED BUTT
IN MAIN DECK.

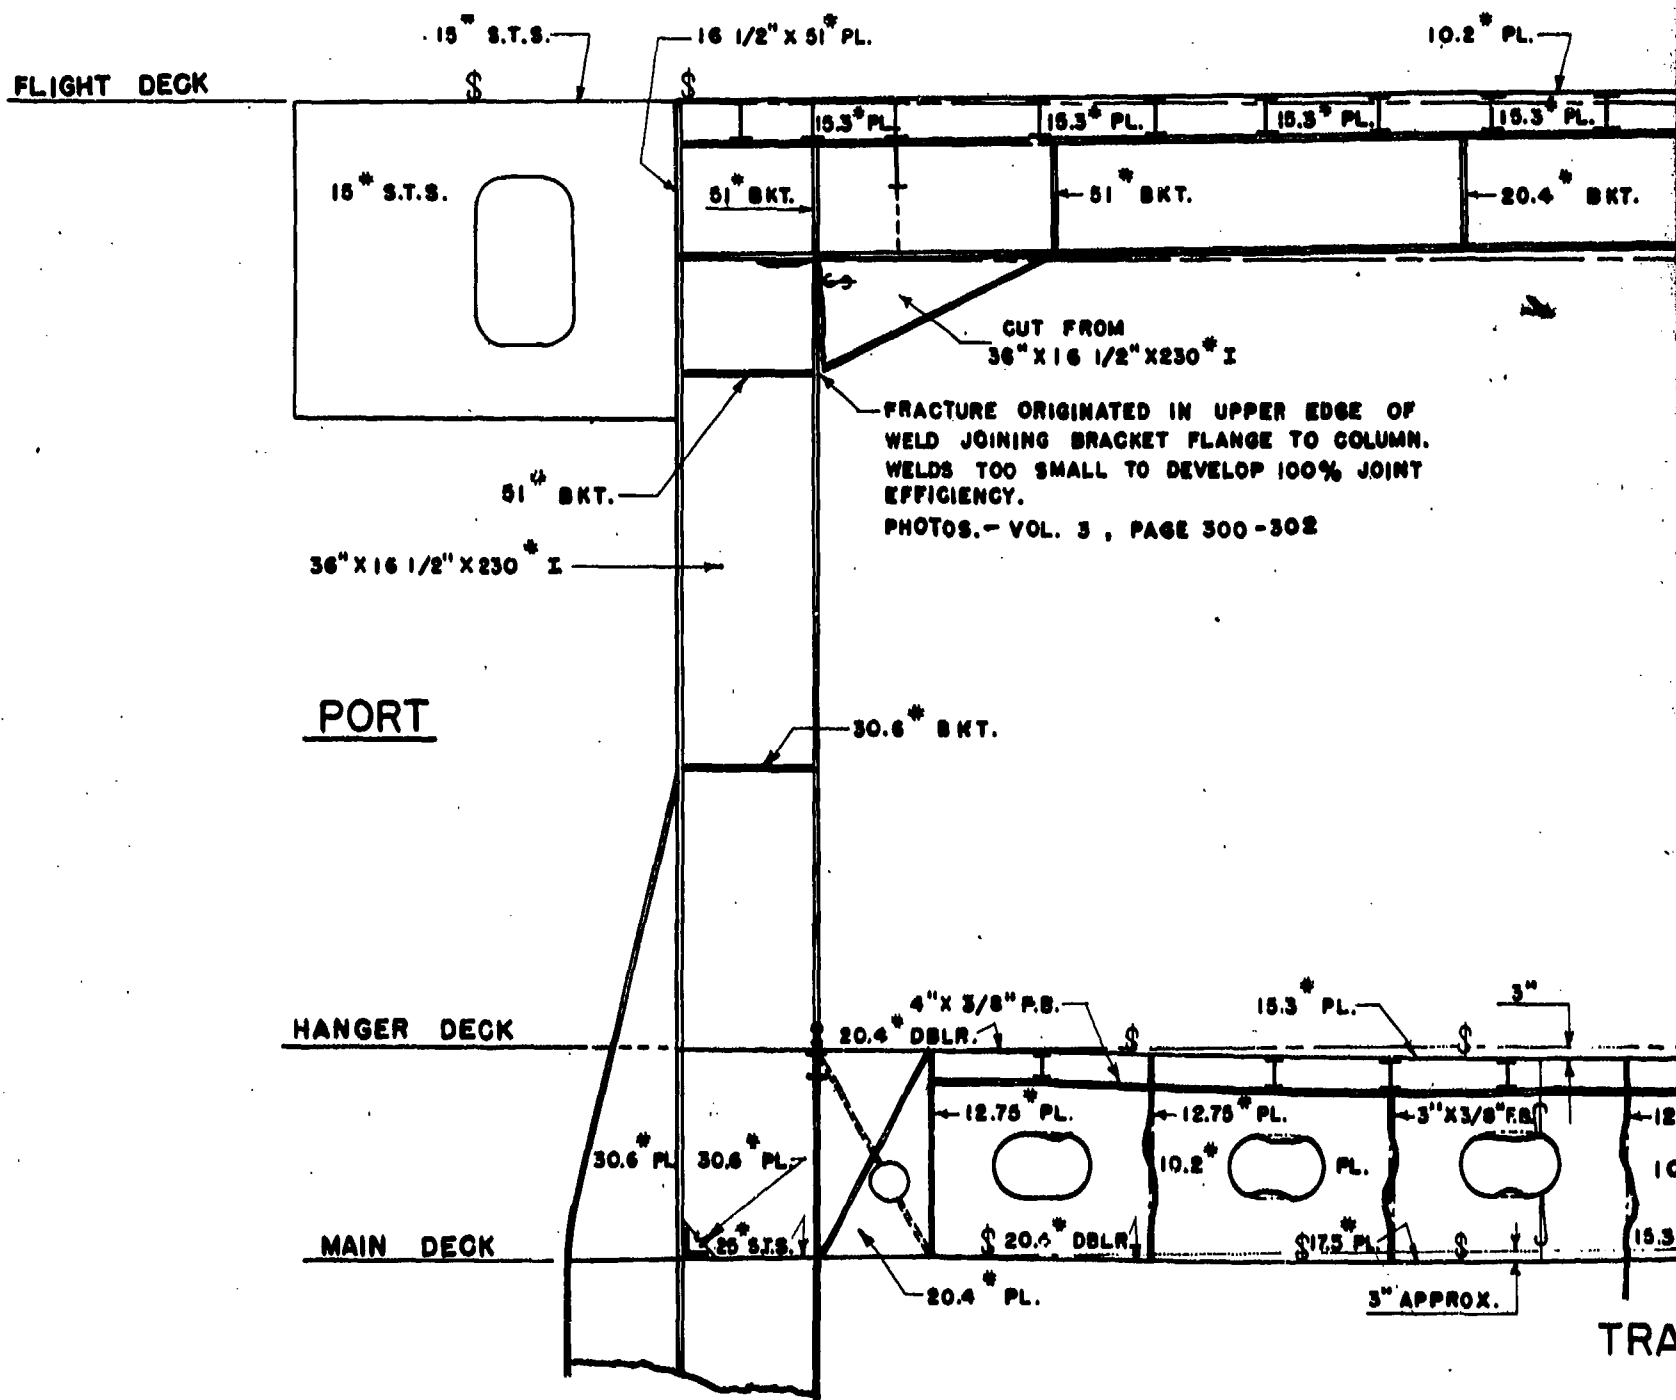
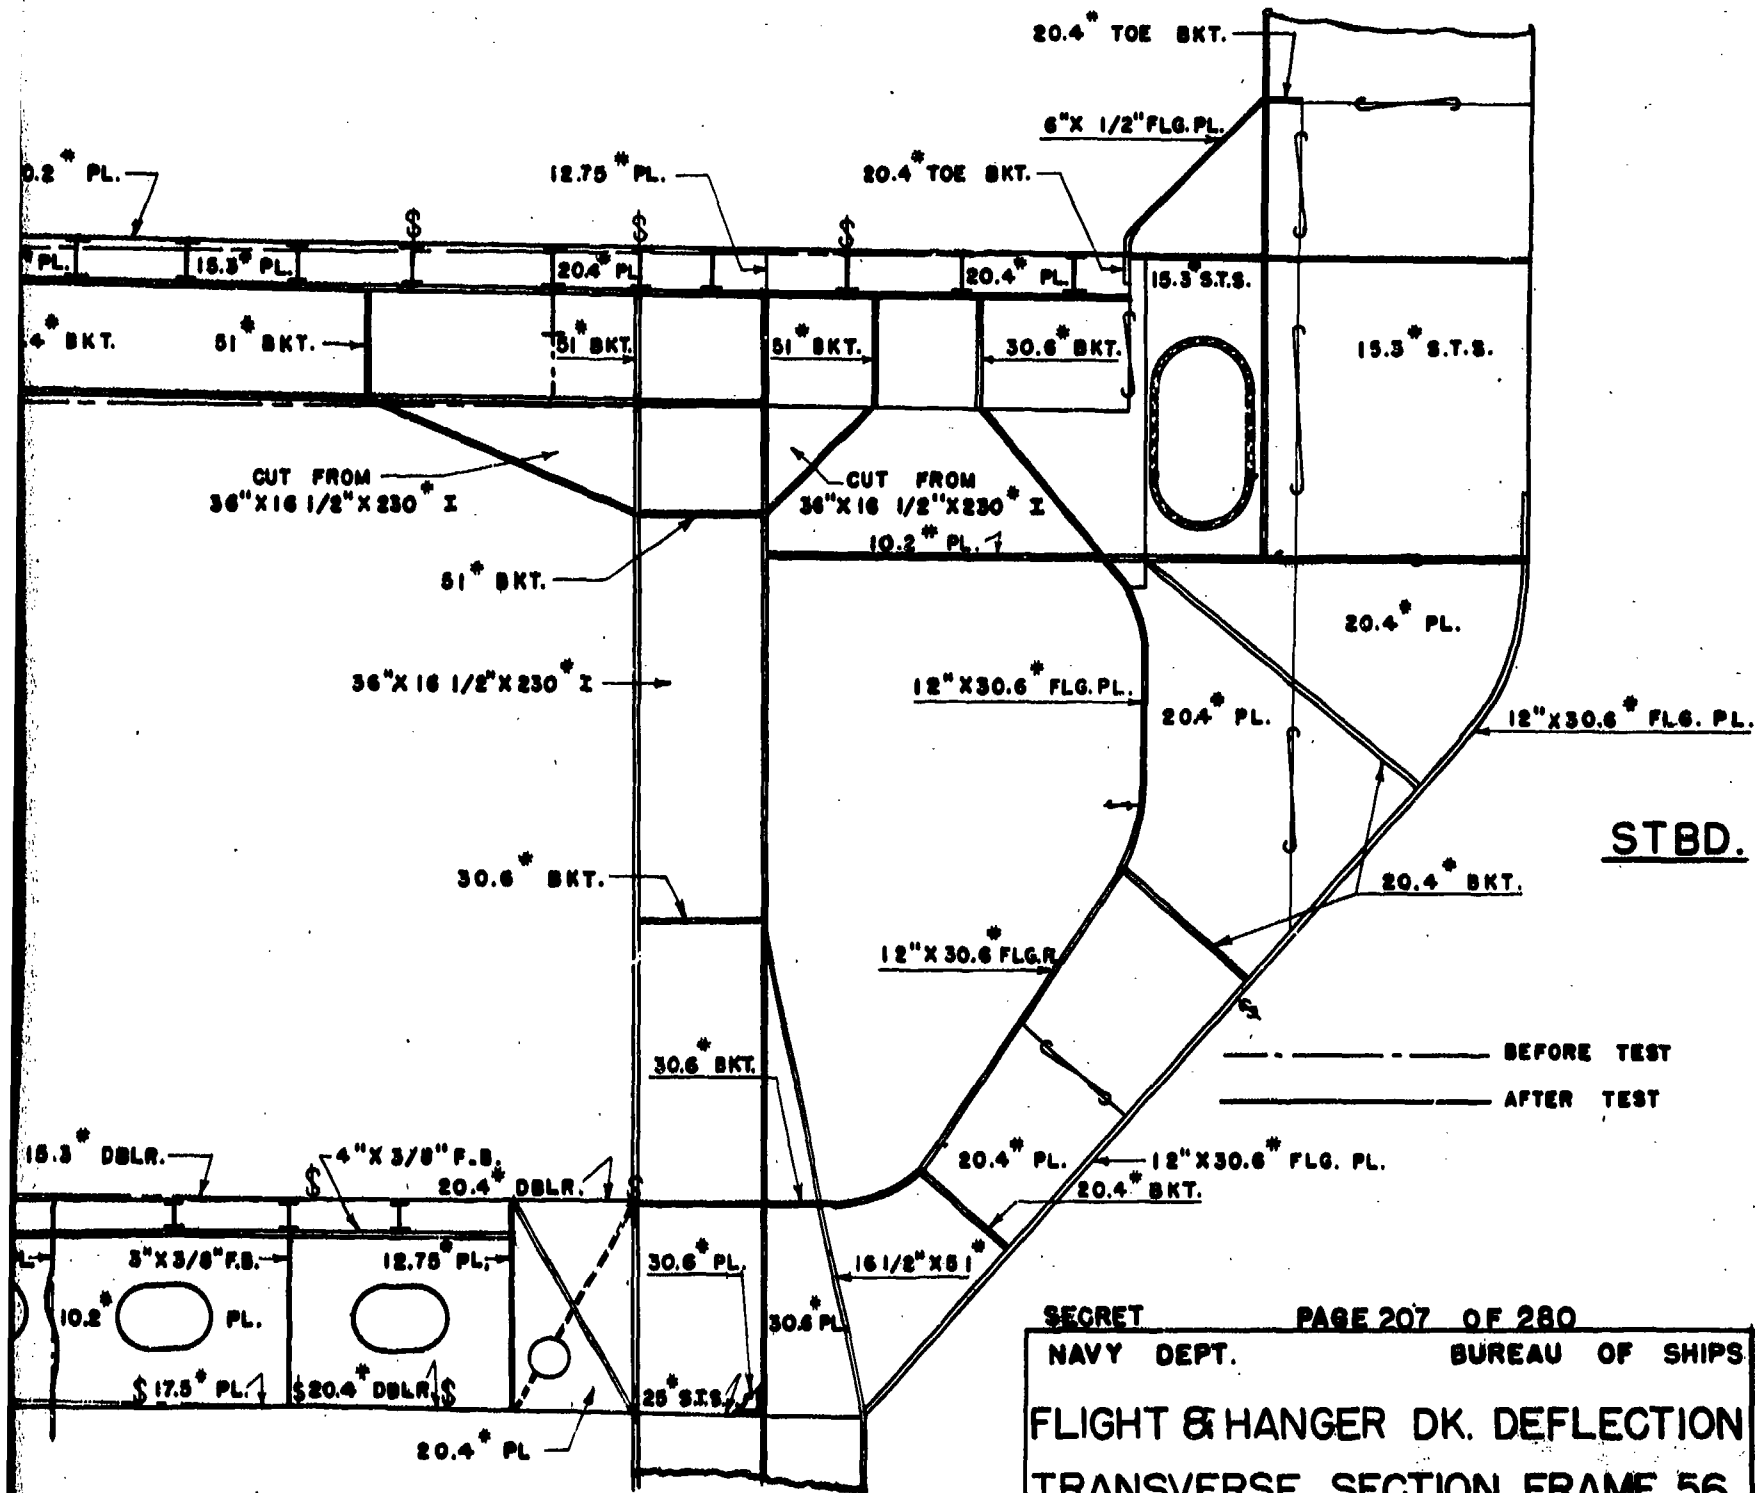
PLATE NO. 5

SECRET PAGE 207 OF 280
 NAVY DEPT. BUREAU OF SHIPS
 FLIGHT & HANGER DK. DEFLECTION
 TRANSVERSE SECTION, FRAME 56
 TEST A
 U.S.S. INDEPENDENCE CVL 22

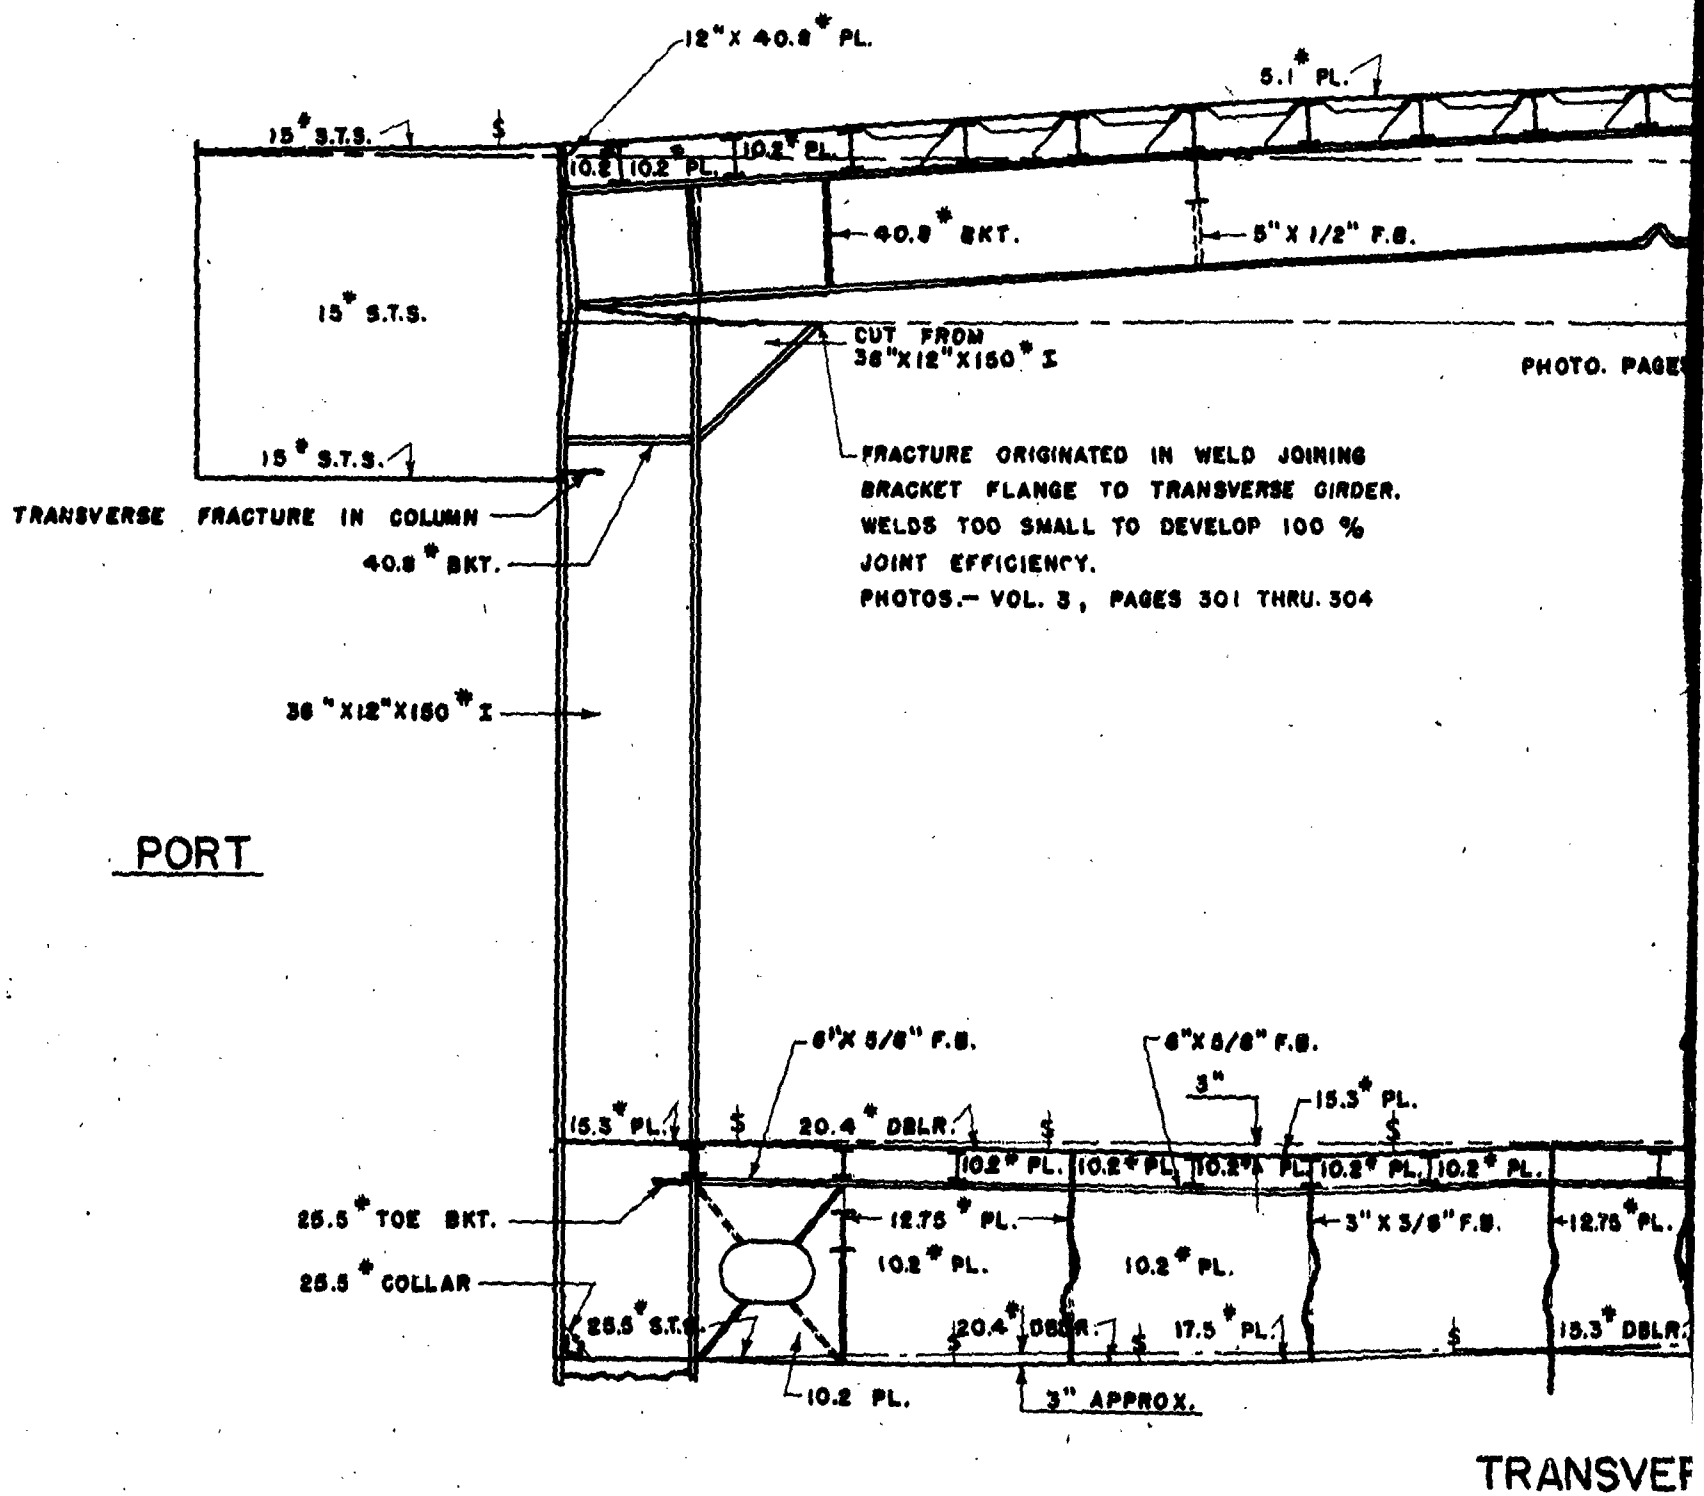
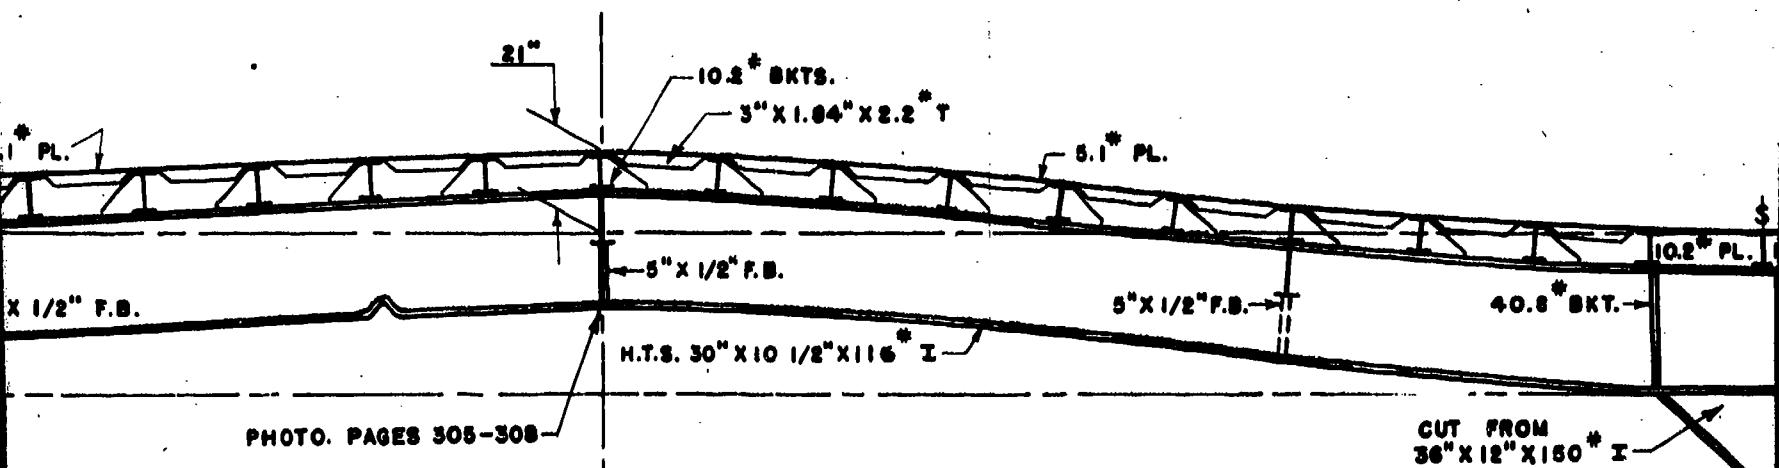
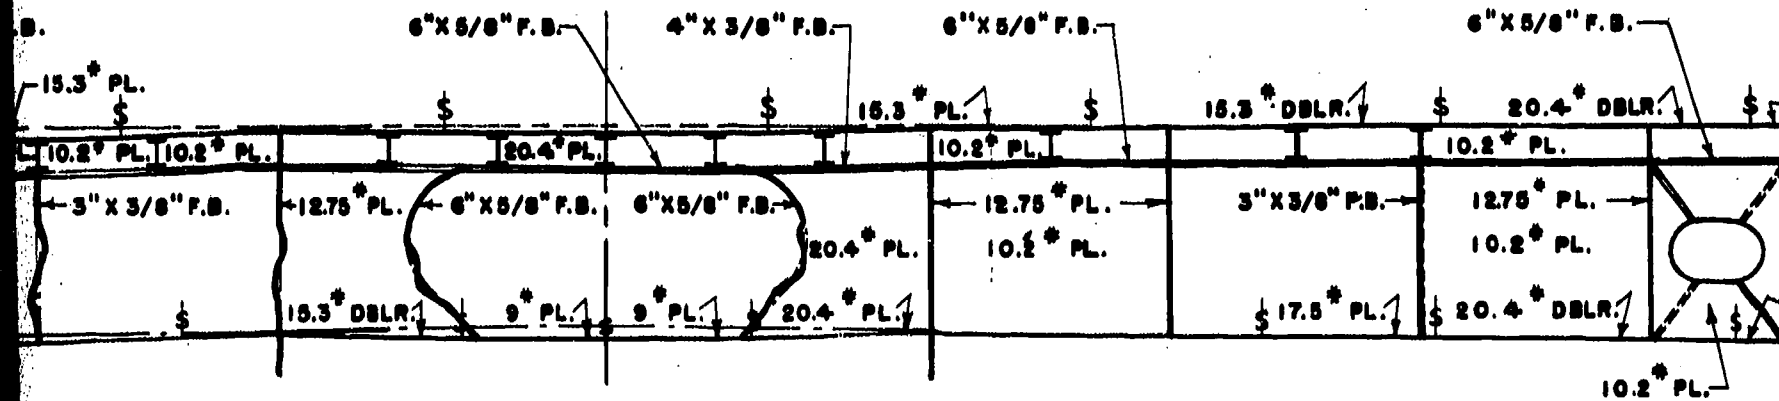
TRANSVERSE SECTION AT FR. 59
 LOOKING FORD.

JOINING
 GIRDER.
 100 %
 RU. 304

FRACTURE ORIGINATED IN WELD JOINING
 TRIPPING BRACKET TO INBOARD FLANGE
 TO COLUMN
 PHOTOS. - VOL. 3, PAGE 309

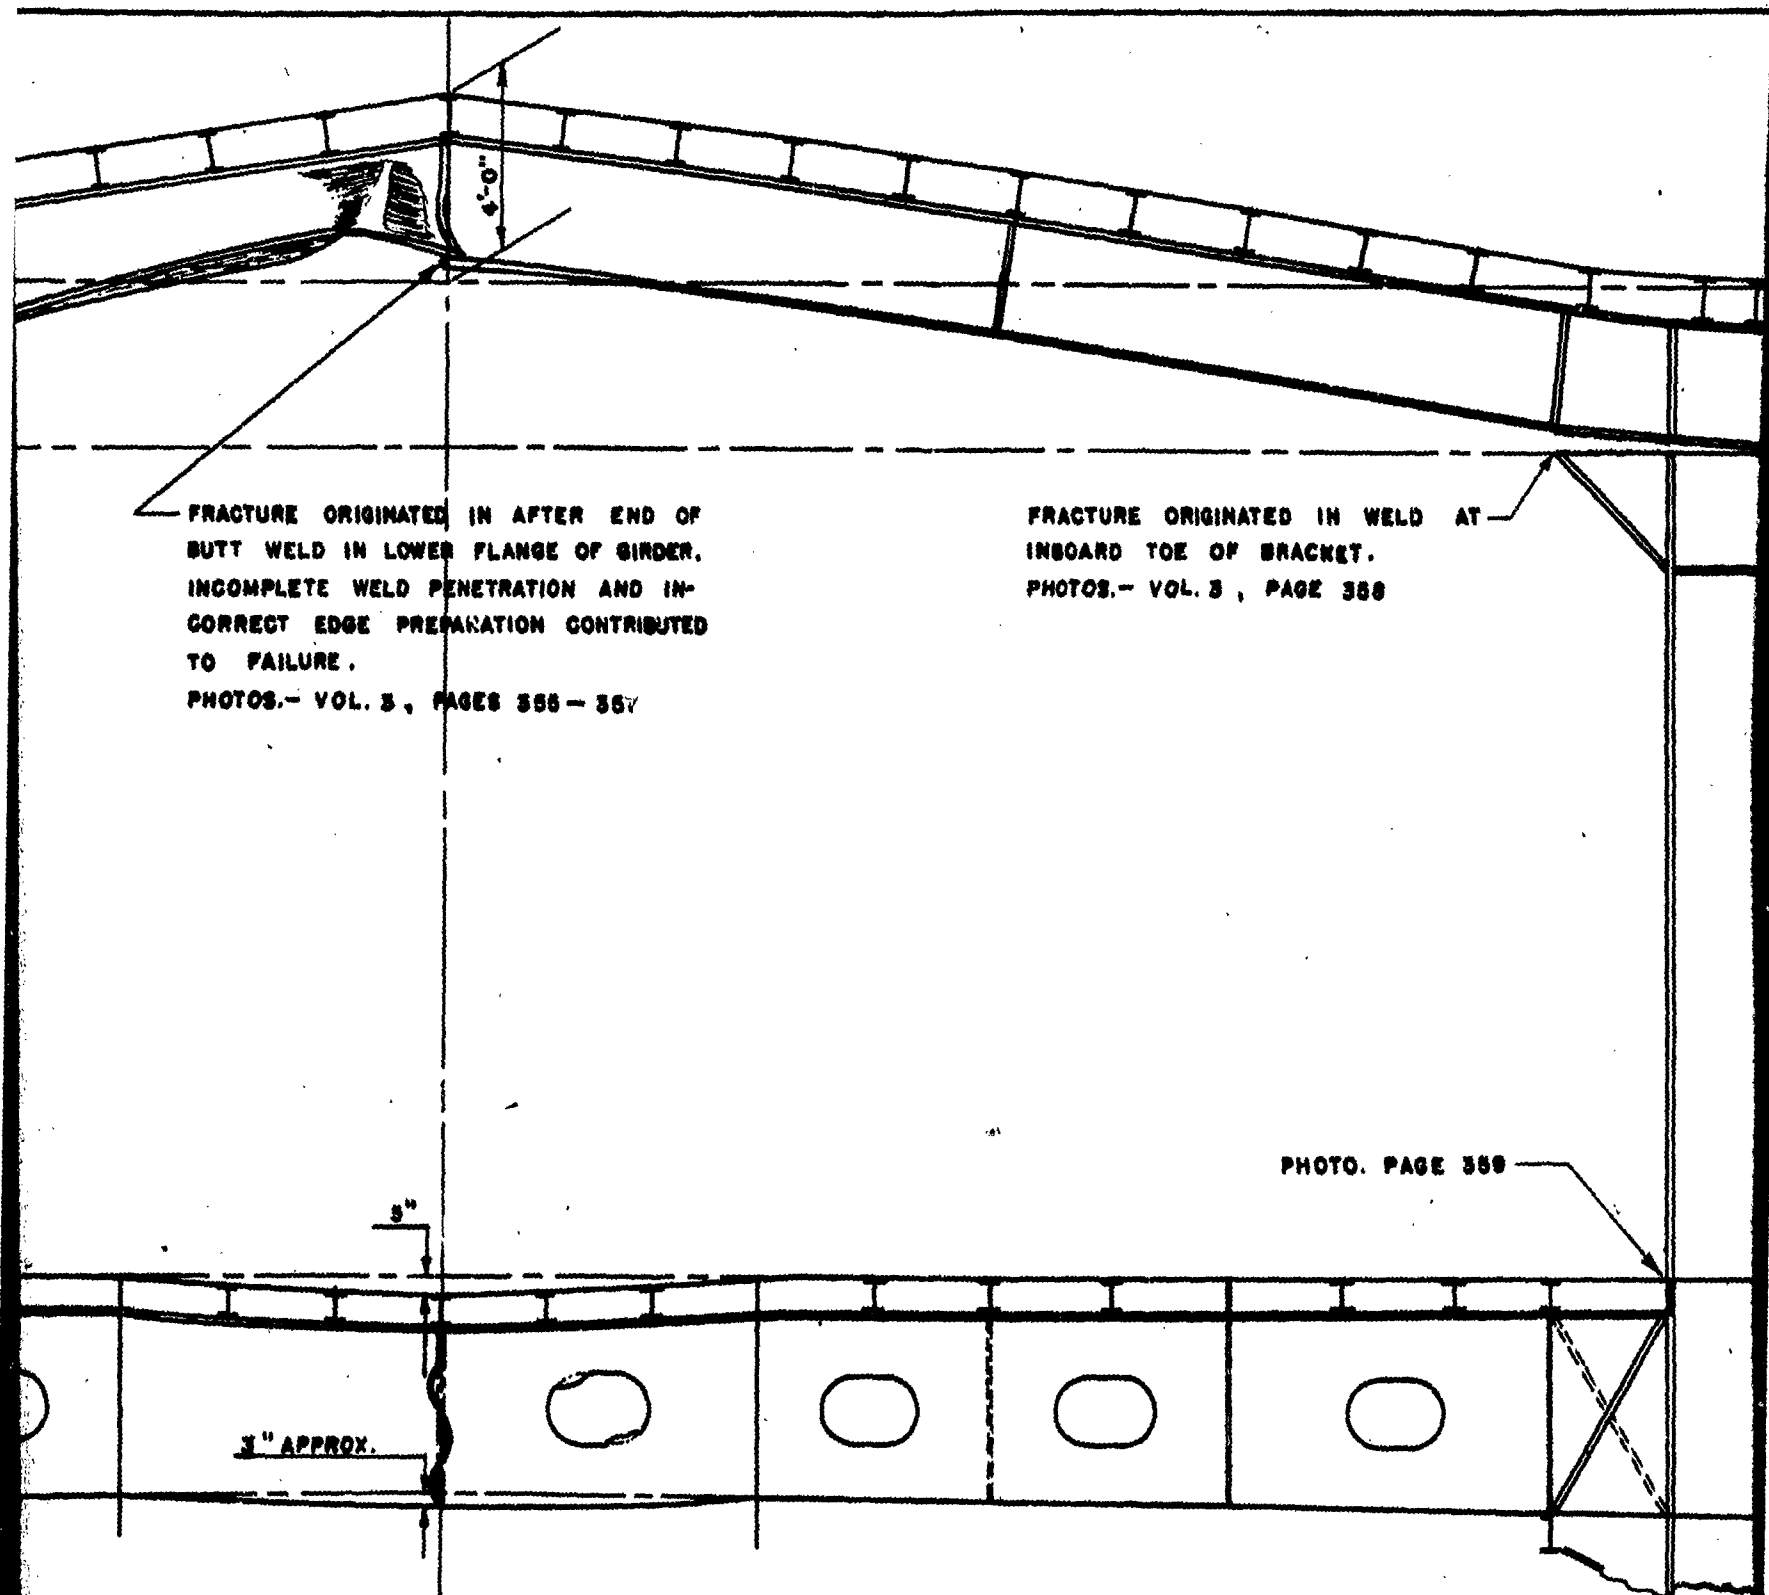
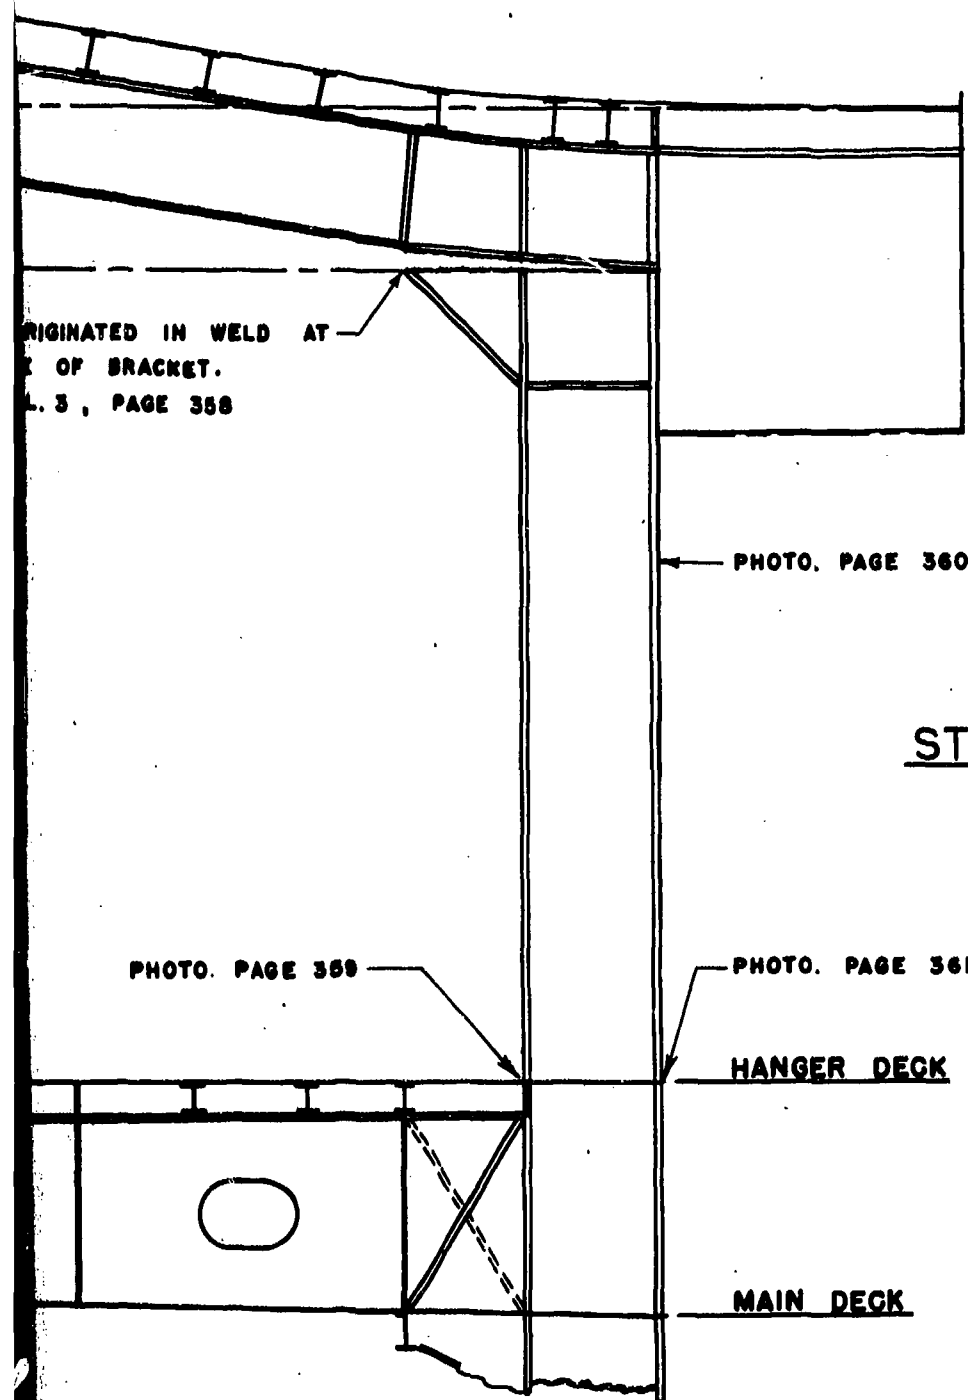
TRANSVERSE SECTION AT FR. 71
LOOKING FORD.

PHOTO. PAGE 360

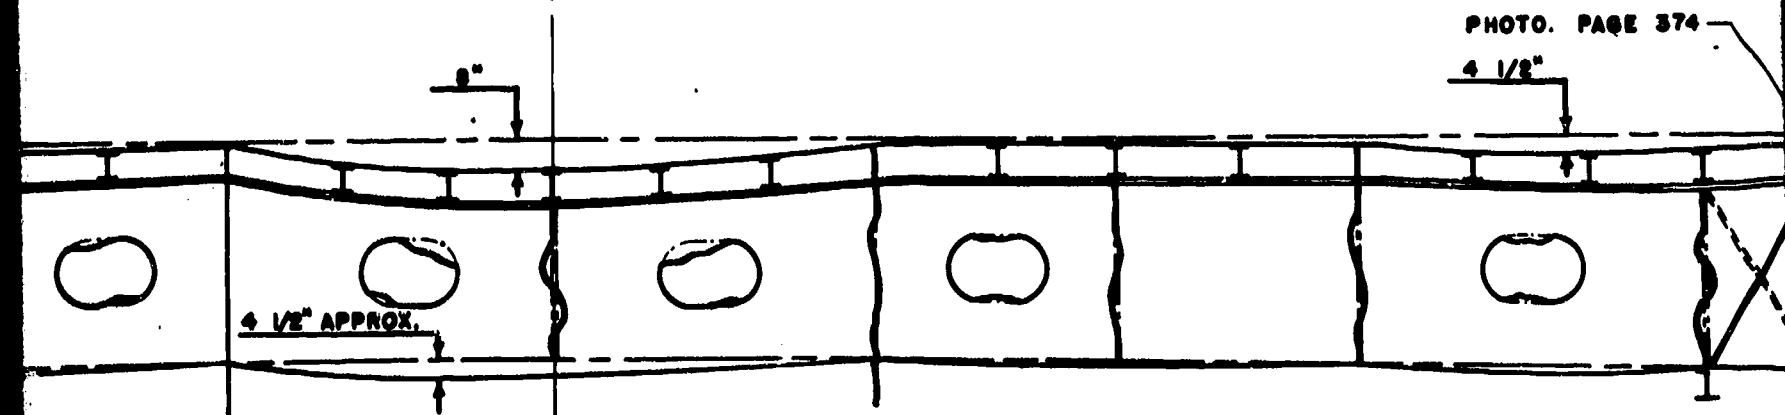
TRANSVERSE SECTION AT FR. 74
 LOOKING FORD.

FRACTURE ORIGINATED AT EDGE OF WELD
 IN TOP FLANGE OF GIRDER.
 PHOTOS.- VOL. 3, PAGES 366-369, 375, 376

FRACTURE ORIGINATED AT UPPER EDGE
 OF WELD JOINING GIRDER AND
 BRACKET FLANGES.
 DISCONTINUITY IN STRUCTURAL DESIGN
 OF CONNECTION CONTRIBUTED TO FAILURE.
 PHOTOS.-VOL. 3, PAGES 370, 372
